CSI Inspection Report

Classic SO#	
Customer Name	
Customer PO#	
Date Received	04/12/21
Manufacturer	SONY
Manuf. Part Number	CX20084-T4
Internal Part Number	
Part Description	Integrated Circuit
Order Quantity	17
Received Quantity	17
Lot Code	N/A
Date Code	0629
Report Number	745405
QC Inspector Name	Ivan P.

P/N: CX20084-T4

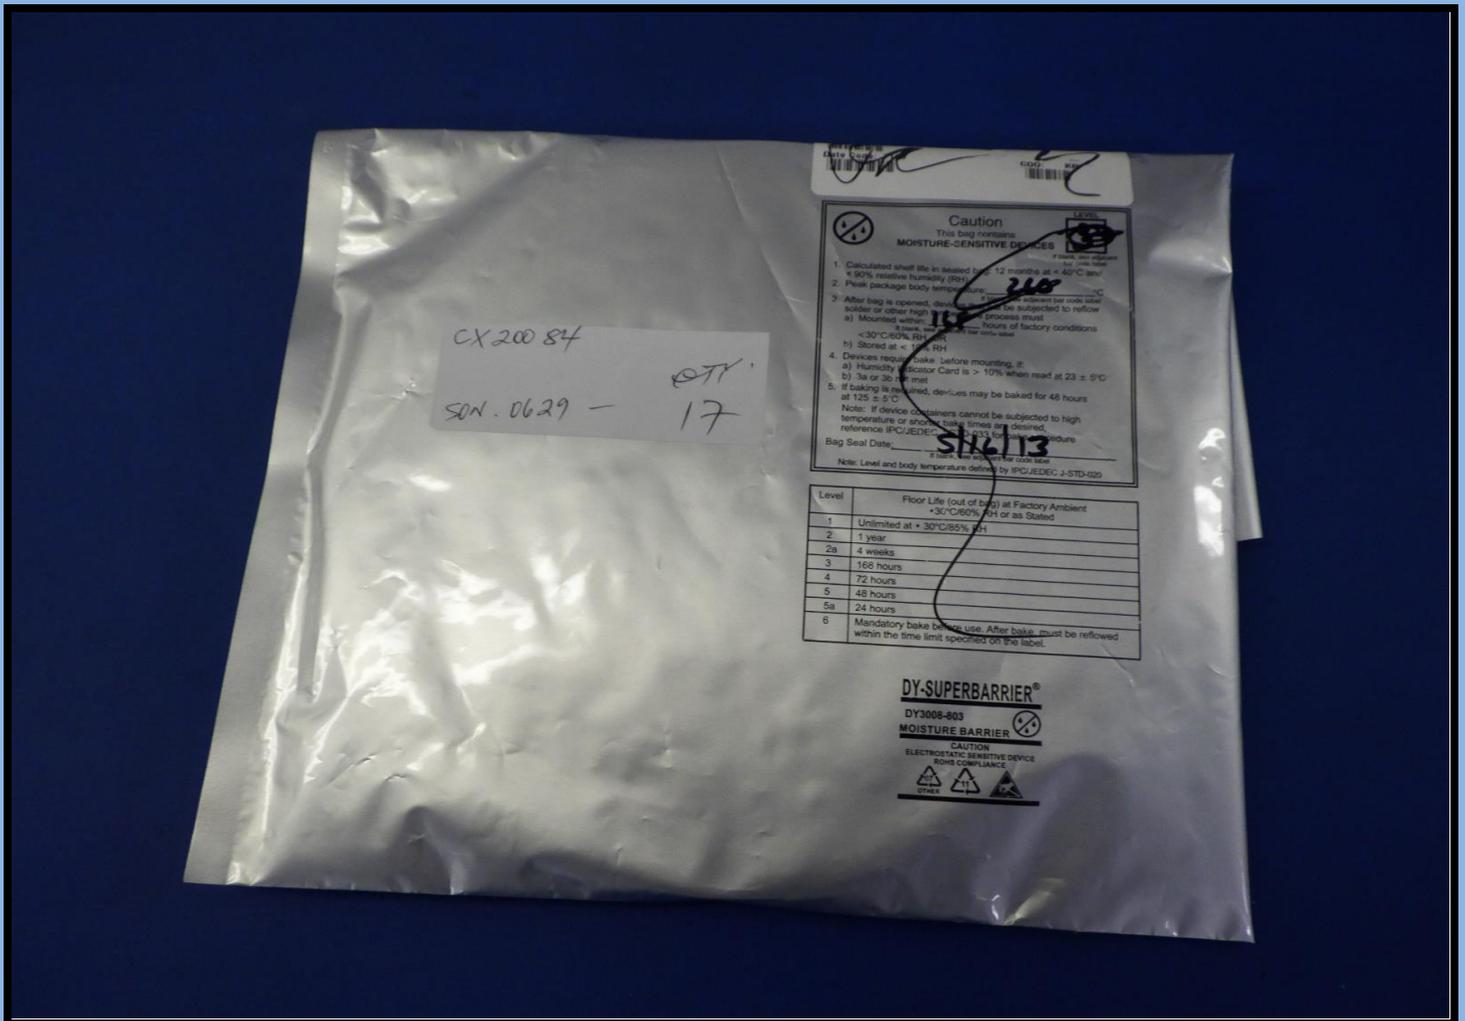
Internal Packaging reveals P/N CX20084-T4 was packaged within 1 ESD Approved Anti Static Bag to offer better protection for the product carrier as well as the MSL 1 parts themselves. No damages were detected or reported.

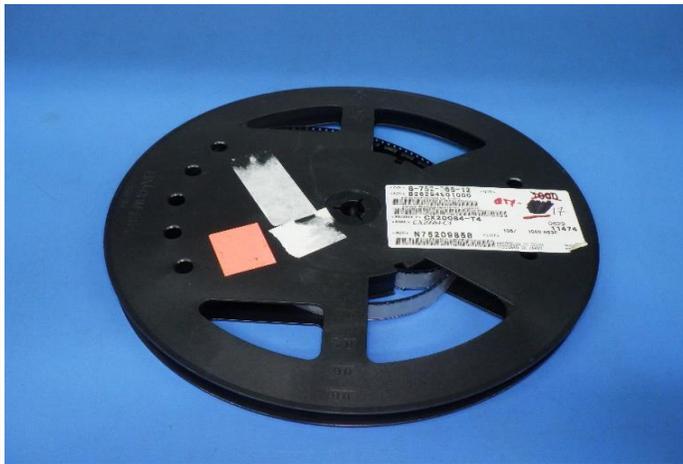
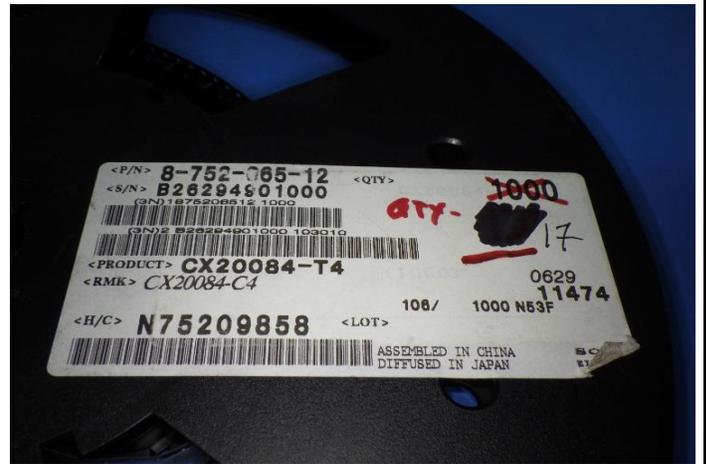
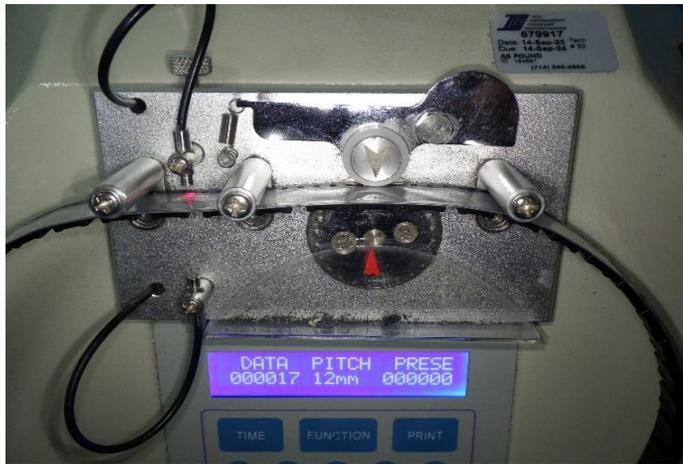
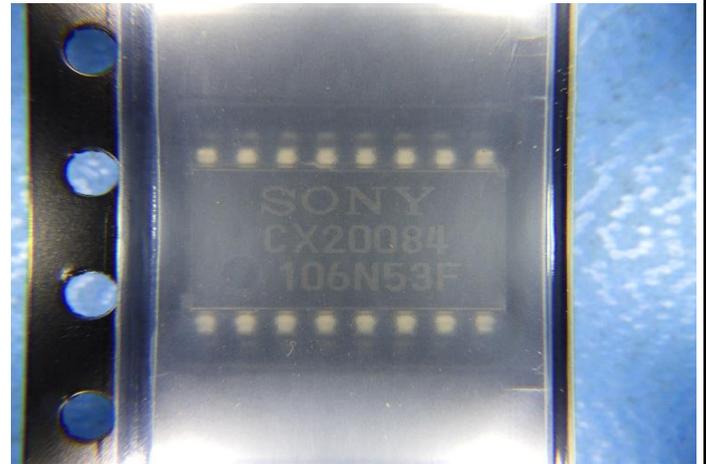
Product Carrier

The carrier method used was 1 cut tape and reel containing a total of 17pcs. The manufacturing label displays related information about the components such as date code, lot code, country of origin, etc. P/N CX20084-T4 in this case was later found to be date code "0629", made in China, but the lot code was N/A.

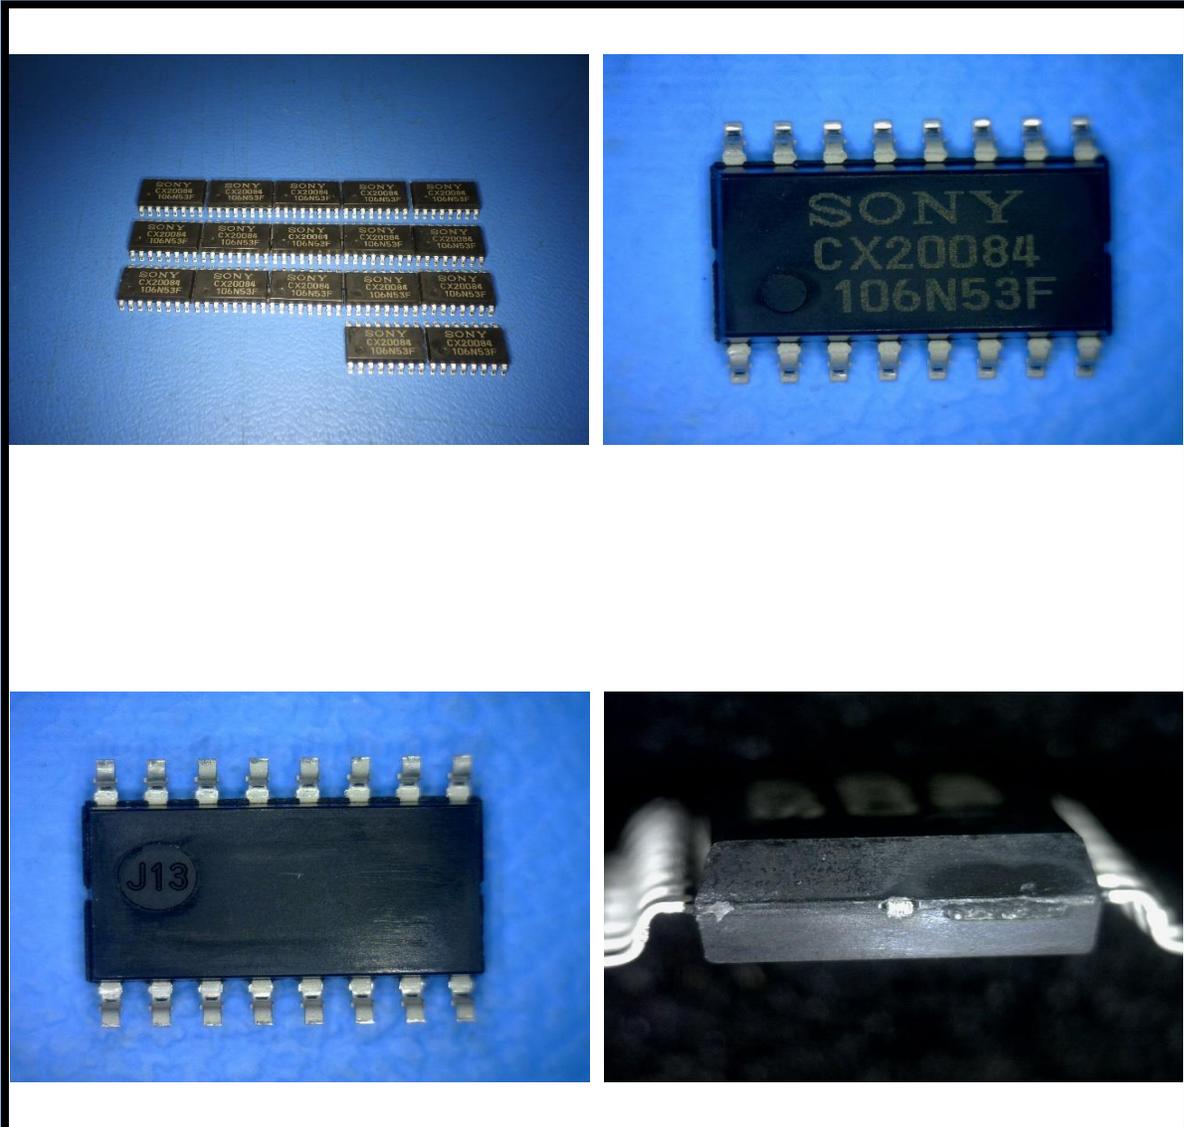
A2 External Visual Inspection

Product detailed inspection was performed on a sampling size of 17pcs.
No abnormalities were found.

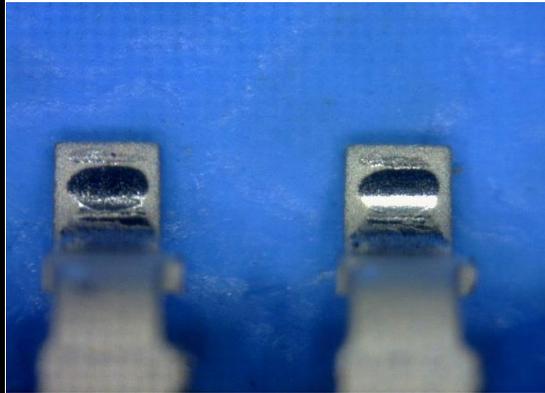
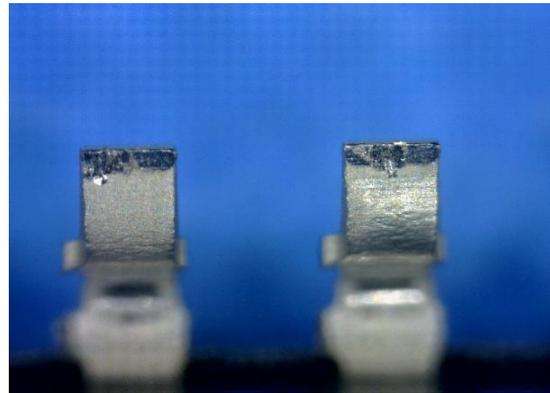
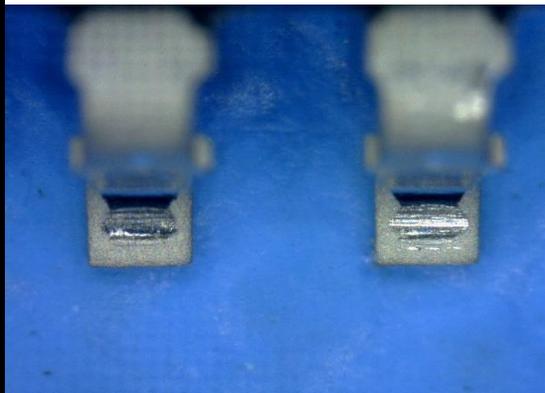
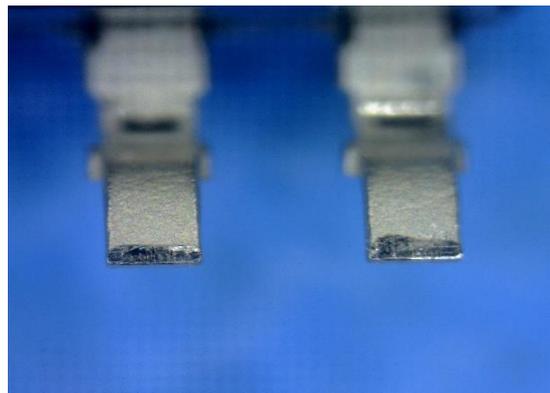
A2 External Visual Inspection

Detailed Lead inspection was performed on a sampling size of 17pcs
No abnormalities were found.

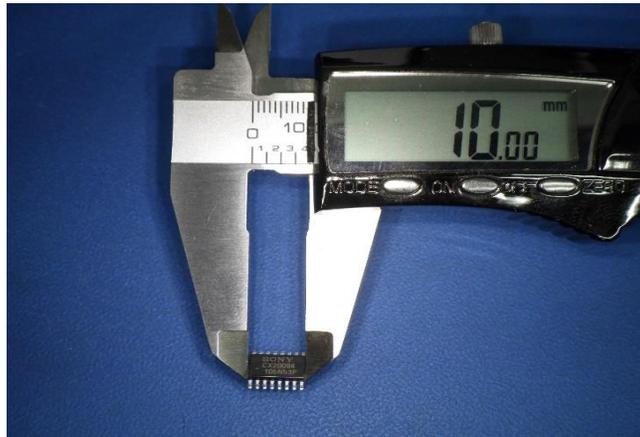
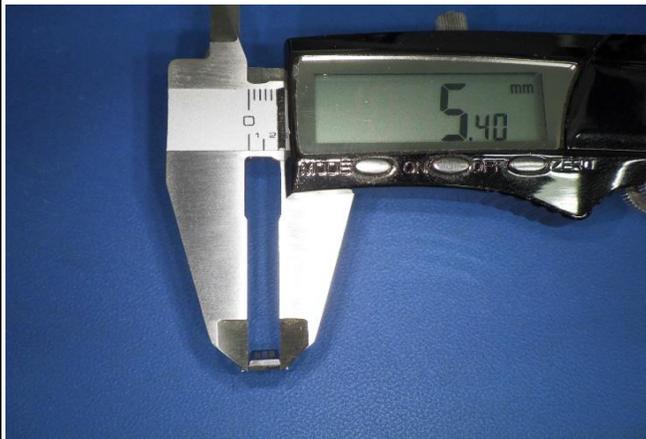
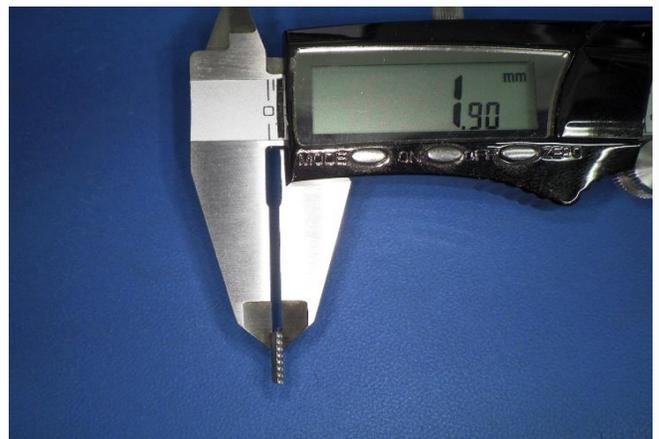
**A2 External Visual Inspection
Component Dimensions**

MEASURED PART DIMENSIONS (IN MM)		
Actual Dim.	In Spec.	Measurement
10.00 mm	10.00 mm	Length
5.40 mm	5.40 mm	Width
1.90 mm	1.90 mm	Height

A sampling size of 17pcs was used to measure the components' dimensions but only one is shown above. We located the datasheet but we were unable to locate the dimensions specification sheet.

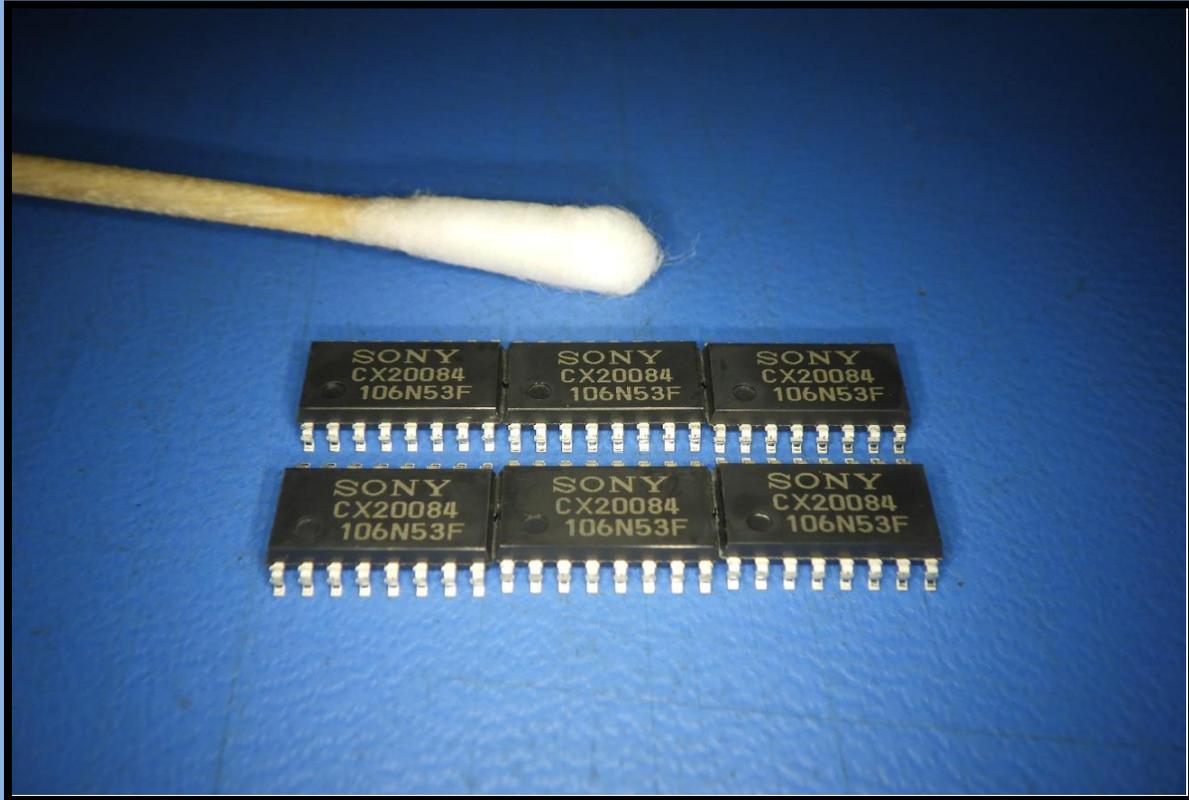
A3 Remarking & Resurfacing (Acetone)

A Chemical wipe test using acetone was performed on 6pcs.
No signs of blacktopping or any extraneous matter was found.

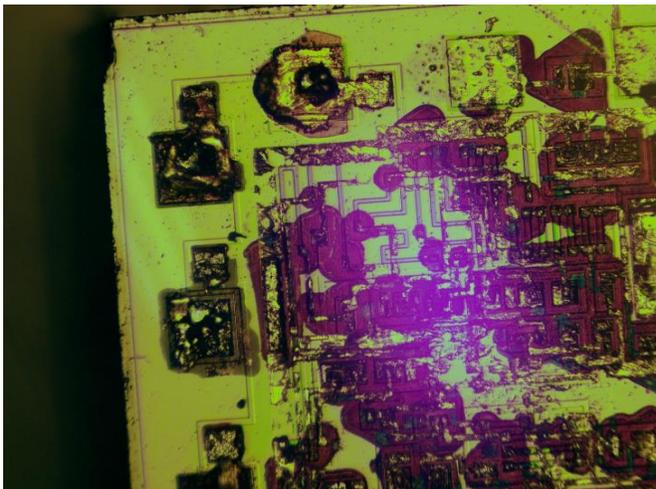
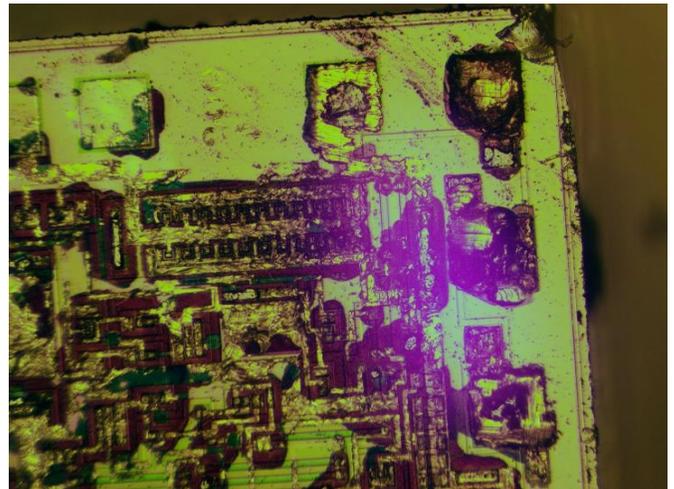
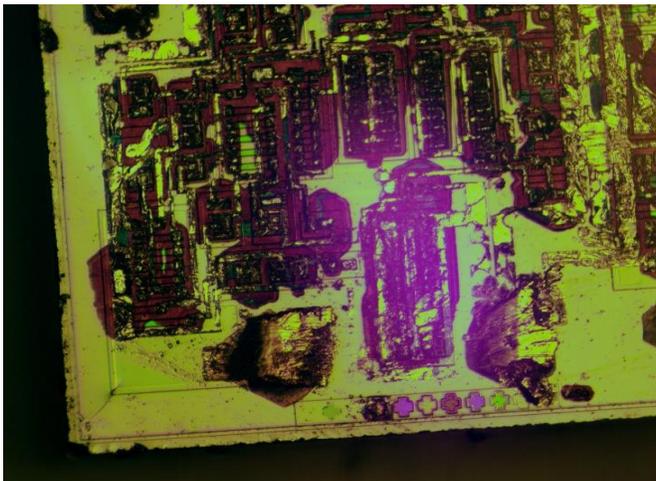
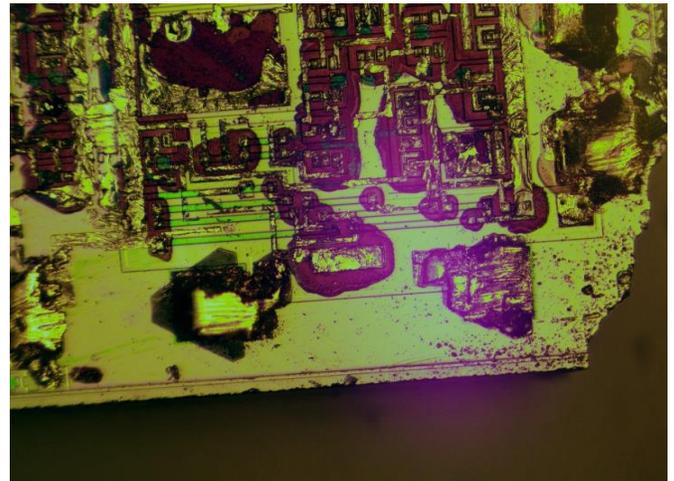
Die Images

Described Decapsulation Recipe				
ACID %	HNO ₃ :	H ₂ SO ₄ :	Temperature:	Time (seconds):
	90	10		120
MODE:		Pulse		Rinse (seconds):
	✓	Vortex		10
Markings Found & Notes				
Manufacturer & Logo			N/A	
Manuf. Part Number			N/A	
Date or Markings			N/A	
Do die markings match manuf. spec?			N/A	
Does die match a reference part?			N/A

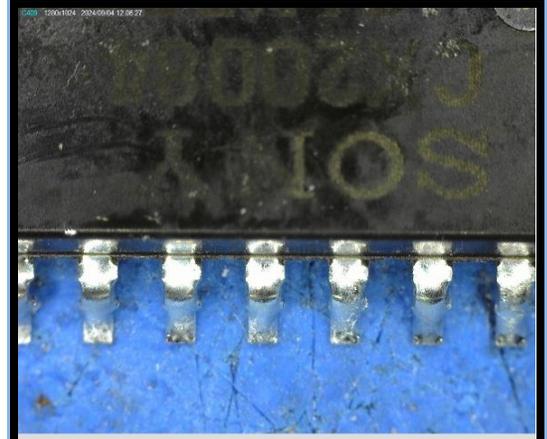
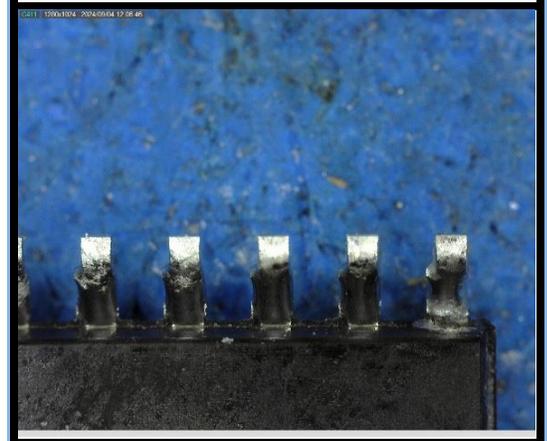
H1 Solder Test Report & Photo

Line	Part Number & Description	Quantity
1	Part Number: CX20084-T4 Internal: MFG: Sony Date Code: 0629	1 pc
Lead Process Description		Results
1 pc from each datecode was tested per J-STD-002D solderability		PASS
